TECHNICAL NOTE 3933

EFFECT OF FIBER ORIENTATION ON BALL FAILURES

UNDER ROLLING-CONTACT CONDITIONS

By Robert H. Butler, H. Robert Bear, and Thomas L. Carter

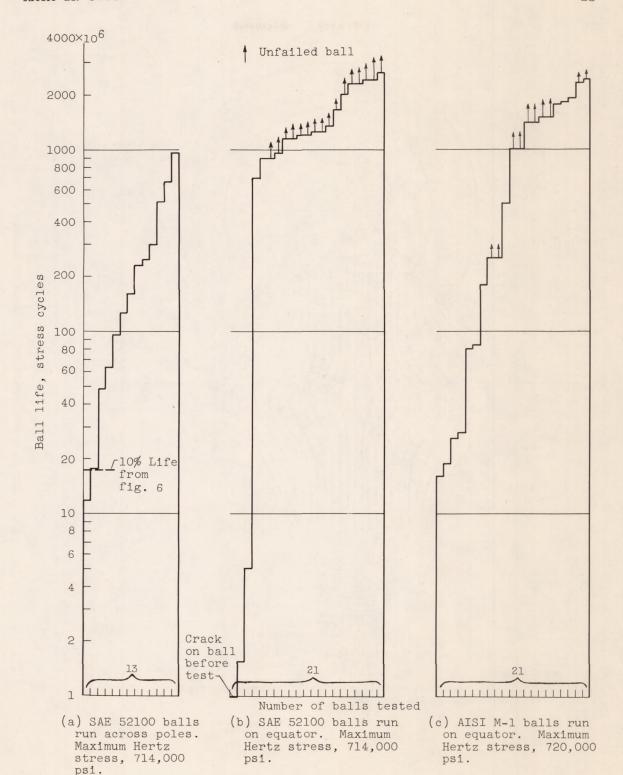
Twenty-one 1/2-inch SAE 52100 balls were tested with holes drilled perpendicular to the plane of the equator so that the track was coincident with the equator. Since the track was entirely within one characteristic surface area, no direct comparison could be made with the polar areas. However, as shown in figure 2, most of these balls (16 out of 21) were unfailed after the number of cycles during which all of the balls running over the poles had failed.

Equivalent data for the SAE 52100 balls run on the equator tested at room temperature cannot be given because of the few failures obtained. A comparison of the scatter in lives between the polar failures and the equator failures is shown in figure 2. The results, except for the three quick failures (fig. 2(b)), indicate that the 10 percent life for these balls could be many times greater than that for the pole failures. The resulting life of the cracked ball indicates that the other early failures may have been caused by similar defects that were hidden.

The results of the AISI M-l equator tests are also plotted in figure 2(c). These results indicate a trend similar to that of the SAE 52100 equator results. This steel was dirtier than the SAE 52100 steel. Slag streaks such as the ones shown in figure 7(a) were found on about one out of every three balls examined at a magnification of 60. These slag streaks undoubtedly contributed to the short lives of these balls. Several failures occurred at these defects. Figure 7(b) illustrates this effect.

Figure 2. - Comparison of tests in which balls ran on equator and across poles. Room temperature; 1/2-inch balls with 0.050-inch hole drilled through; lubricant flow rate, 5 milliliters per hour; lubricant, synthetic sebacate.

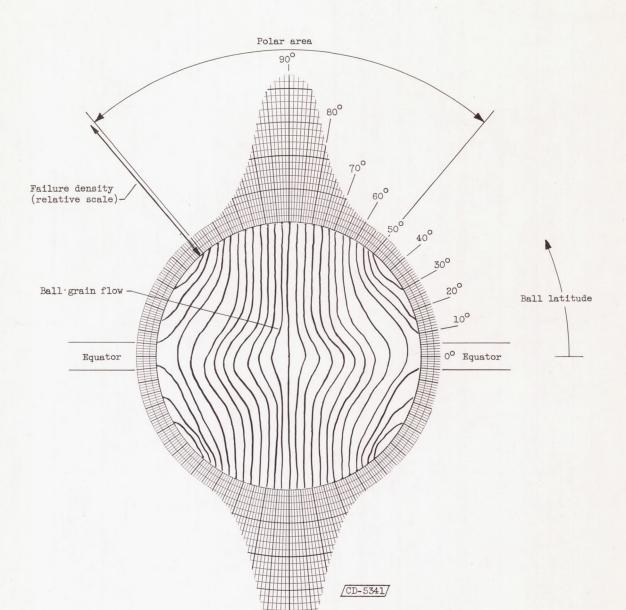
Figure 3 is a plot of failure density as a function of ball latitude for the 29 failures obtained in the stress-life tests. The data were plotted by orienting all failures along a given longitude and dividing the number of failures in a zone between two latitudes by the ratio of the zone area to the hemispherical area. This plot shows a very marked increase in the density of failures at higher ball latitudes, that is, in polar areas. Such a plot for a homogeneous material would produce a circular band.

Figure 3. - Failure density plotted against ball latitude with cross section showing grain flow. 9/16-Inch SAE 52100 balls.

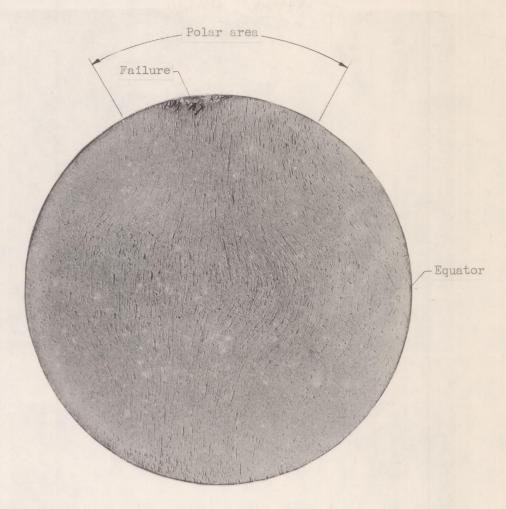
Since the primary characteristic which distinguishes the polar area from the remaining portion of the ball is the orientation of the fiber perpendicular to the surface (fig. 4(a)), one might expect the equator area, which often has a similar grain flow, to be weak in fatigue also. This equator end grain results from the removal of the flashing formed during upsetting of the ball. This condition can be seen in figure 4(b) and to some extent in figure 4(a). Only one failure was directly on the equator, but no distinguishing appearance of any significance was noted. This series of tests does not show any conclusive evidence of equator weakness or strength. However, a large portion of the nonpolar failures have, from surface examination, some pronounced imperfections which have a consistent orientation to the equator. Of the 18 balls failing other than at the equator or in a polar area, nine had a crack or open inclusion perpendicular to the ball equator and passing through or collinear with a fault line in the fatigue pit. Examples of this condition are shown in figure 5. Of the remaining nine failures, one was at the location of a

(a) Fiber orientation.

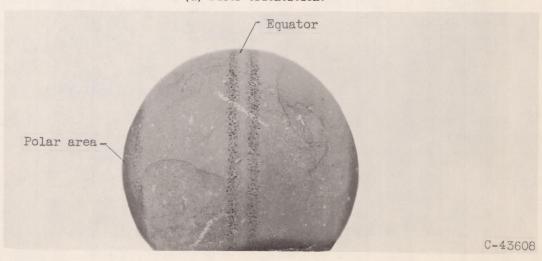
(b) Poles and equator.

Figure 4. - Fiber orientation on SAE 52100 balls (macroetched).

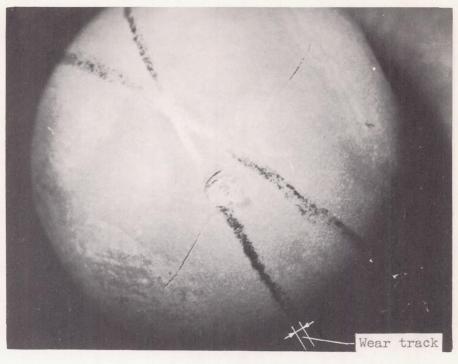
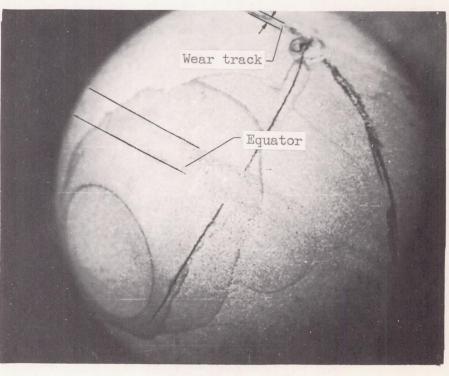
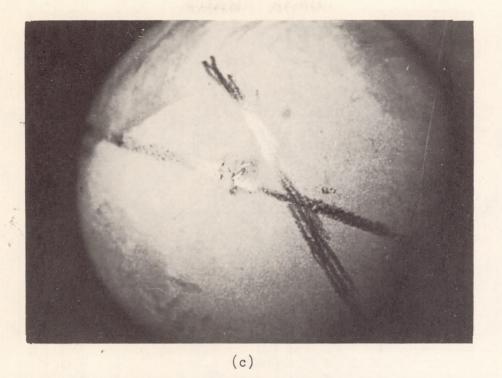
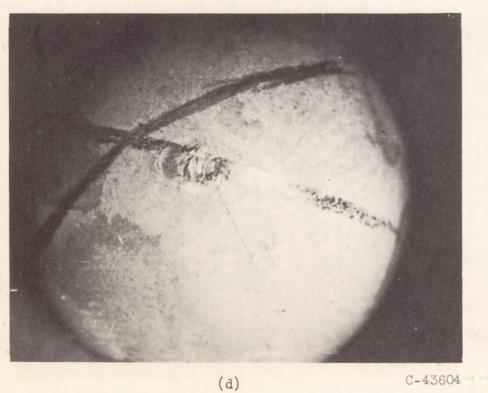
large corrosion pit detected in the prerun inspection, and three were on balls having fine corrosion detected before running. The remaining five balls had no cause of failure apparent to surface examination. Metallographic investigation is planned as a followup to these tests.

Figure 5. - Typical failure-causing inclusions perpendicular to equator and coincident with failure fault line.

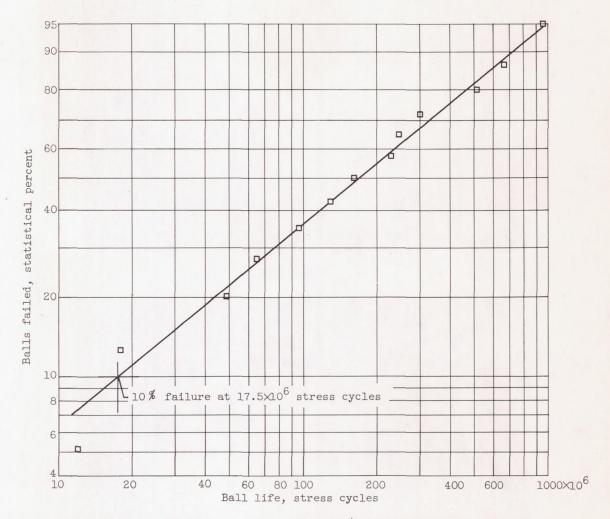
Effect on life. - Fiber orientation also had an effect on life of SAE 52100 balls tested at room temperature. Figure 6 is a Weibull plot of the lives of the balls running over the poles. The ordinate is the log log of the reciprocal of the fraction of the test balls surviving for a given life, and the abcissa is the log of life in millions of stress cycles. This method of data presentation is standard for bearing fatigue failures; however, a brief outline of the procedure is given in appendix C. The 10 percent life is interpolated from the curve and is equal to 17.5 million cycles for this group of balls.

Effect on life scatter. - The slope of the Weibull line for the pole failures of the 1/2-inch balls (fig. 6) is a measure of the dispersion of the life data. The slope of the line compares favorably with the accepted value given for rolling-contact bearings (10/9) in reference 7.

Figure 6. - Weibull plot of stress life of 1/2-inch SAE 52100 balls run over poles. Maximum Hertz stress, 714,000 psi; room temperature; lubricant flow rate, 5 milliliters per hour; lubricant, synthetic sebacate.

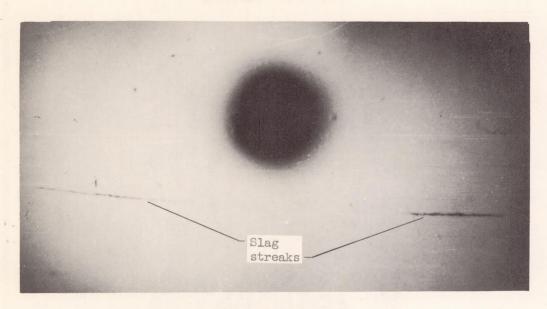
(a) Representative slag streaks.

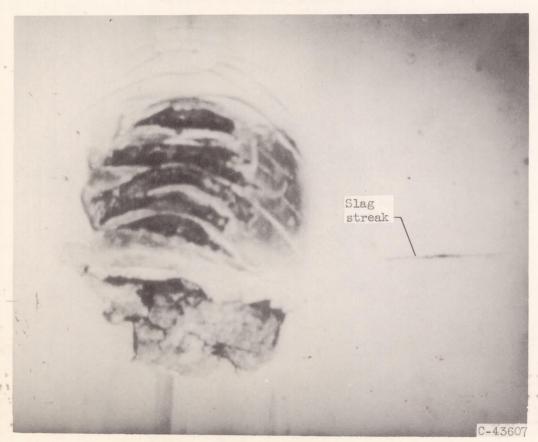
(b) Failure originating at slag streak.

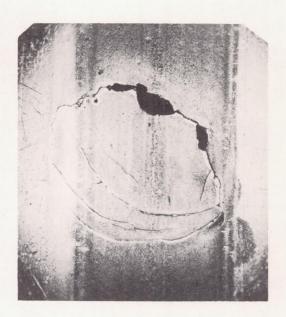
All failures observed were similar in appearance, and the extent of spalling ranged as shown in figure 8(a) and (b) (ref. 8). The spalls were similar to those encountered in full-scale bearing failures. Polar failures are the same in appearance as other failures; figure 9 is a macroetched section through a typical pole failure.

(a) Ball track fatigue failure, before spalling.

(b) Ball track fatigue failure, after spalling.

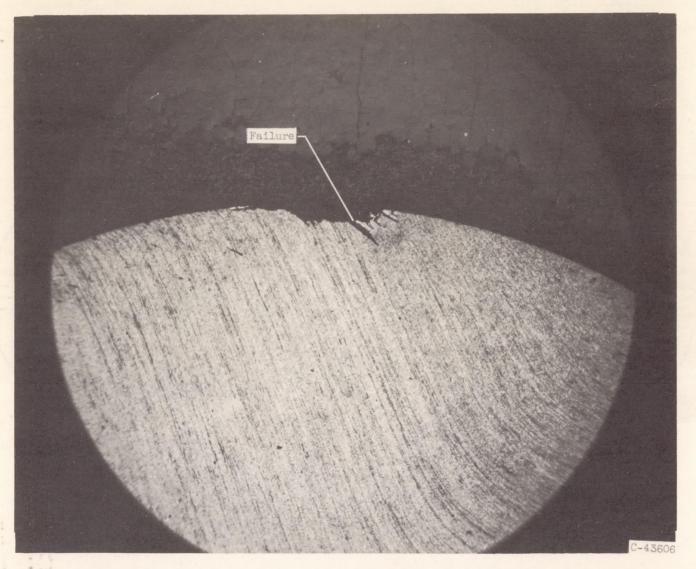
Figure 9. - Pole failure on SAE 52100 ball (sectioned and macroetched).
